## Technical Service Bulletin

**Product Description:** All AMSOIL Motor Oils

**Subject:** Chlorine-containing potentially corrosive aftermarket engine oil treatments

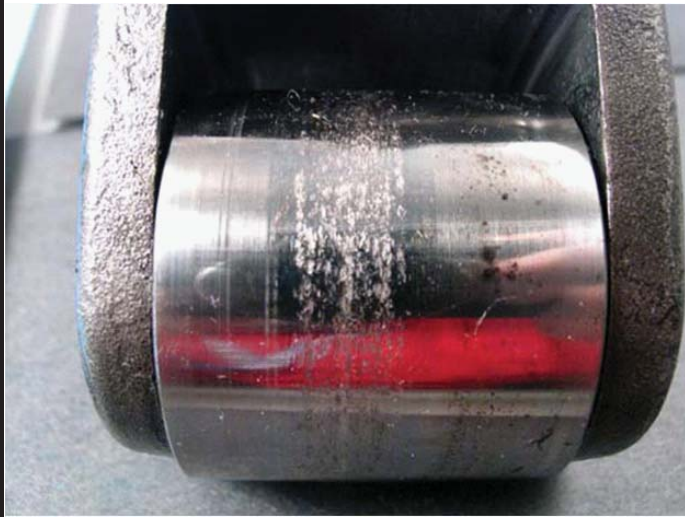
**Figure 1**

The Cummins parts analysis determined the engine failure was the result of a corrosive attack to the cam follower pins, causing valve and injector camshaft lobe failures (see Figures 1-2). Five injector lobes and four valve lobes were significantly spalled, meaning the metal flaked off the surface of the lobes. Analysis of the injector pin and valve pin showed corrosive attack in both the wear and non-wear areas of the pins, while severe galling was observed on the cams and cam follower pins. Galling is the transference of material when moving parts are no longer fully separated and protected. Furthermore, surface analysis showed peaks of chlorine in the actual metal surface, which is not normally present on a cam follower pin under normal operating conditions (see Figure 3).

Galling to spalling damage on an intake valve cam follower roller in a Cummins OTR engine. Photo courtesy of Cummins Inc.

Aftermarket oil additives are *not recommended* for use with AMSOIL synthetic motor oils. AMSOIL synthetic motor oils are fully formulated to provide superior protection and performance; use of aftermarket additives will detract from their performance and possibly lead to engine failure. Use of aftermarket oil additives not approved by AMSOIL INC. will void the AMSOIL Limited Warranty.

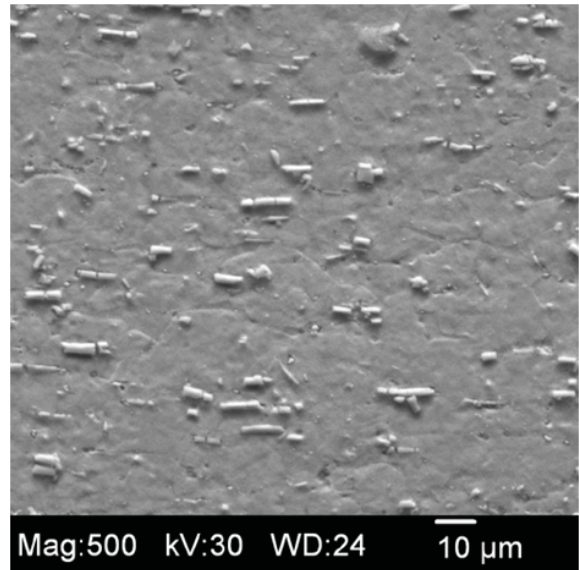
**Figure 2**

Corrosive attack to the roller to pin contact area of an injector cam follower pin in a Cummins OTR engine. Photo courtesy of Cummins Inc.

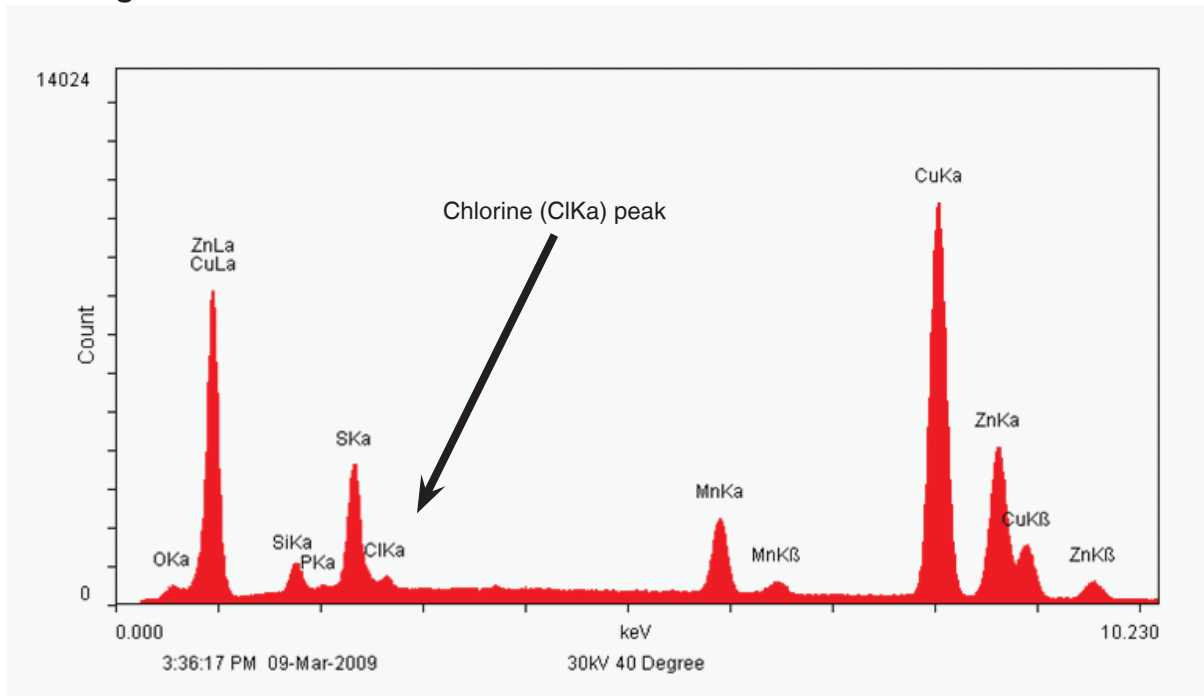
**Figure 3**

The chemical data on the lubricant and surface analysis of the failed engine parts revealed the root cause of the failure was corrosive wear. Acidic components in lubricants directly lead to corrosive wear. In this case, an abnormal amount of chlorine was found in the engine oil. Chlorine, when combined with hydrogen and water in the engine, can create hydrochloric acid. This, in turn, can cause severe TBN depletion, which was the case with this Cummins engine. It was determined that a chlorine-containing additive was used when an oil sample from the engine tested at 11,000 ppm of chlorine. The result was an extreme corrosive environment which was responsible for the upper end engine failure within 195,000 original miles.

An EDS spectrum of the pin surface in the roller to pin non-contact area of an intake valve cam follower pin. Notice the peak in chlorine (ClKa). Photo courtesy of Cummins Inc.
